ACT Disabled Parking Review - Group Centres

September, 2008

Department of Territory and Municipal
Services

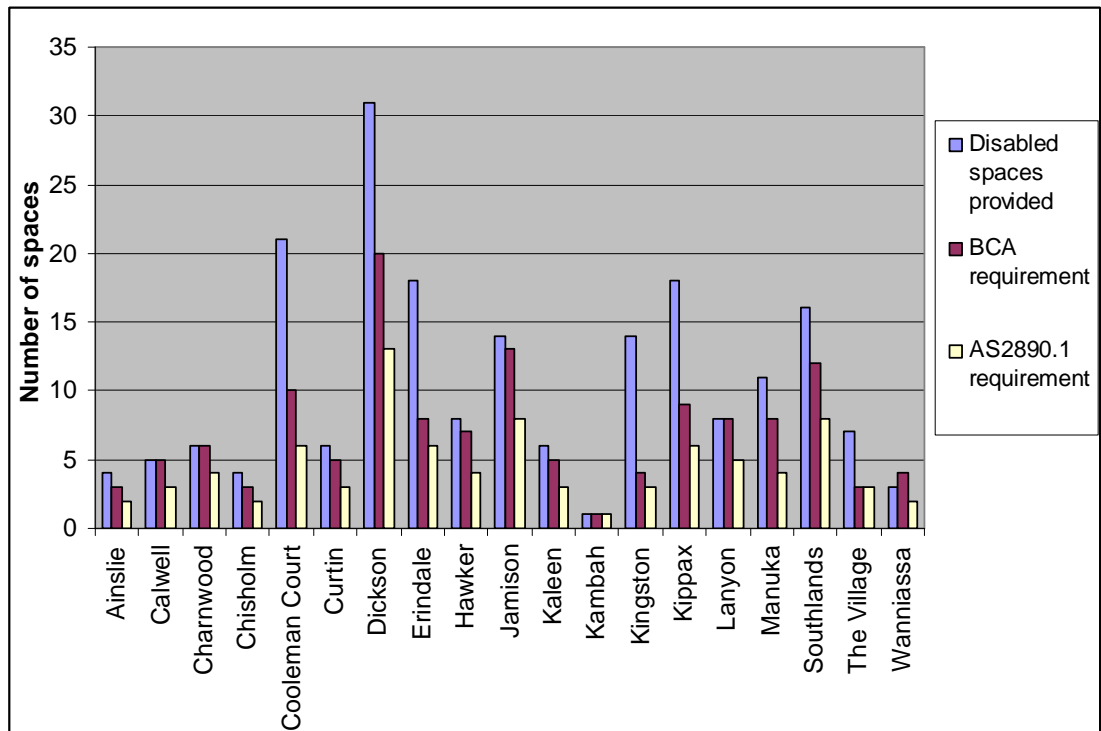
Figure 2-1: Conformance with provision requirements

The results indicate that there is good compliance with regard to the total number of disabled car spaces within Canberra Group Centres. Only Wanniassa Group Centre was not fully compliant, requiring a single car space to meet BCA requirements.

Table 2-40: Conformance to BCA and AS2890.1

Percentage disabled required	No. Parking Spaces Existing		No. Disabled Parking Spaces Required	
	Standard	Disabled provided	BCA	AS2890.1
Ainslie	113	4	3	2
Calwell	229	5	5	3
Charnwood	271	6	6	4
Chisholm	157	4	3	2
Coleman Court	464	21	10	6
Curtin	222	6	5	3
Dickson	1033	31	20	13
Erindale	506	18	8	6
Hawker	332	8	7	4
Jamison	617	14	13	8
Kaleen	241	6	5	3
Kambah	282	1	1	1
Kingston	208	14	4	3
Kippax	470	18	9	6
Lanyon	372	8	8	5
Manuka	400	11	8	4
Southlands	627	16	12	8
The Village	464	7	3	3
Wanniassa	191	3	4	2

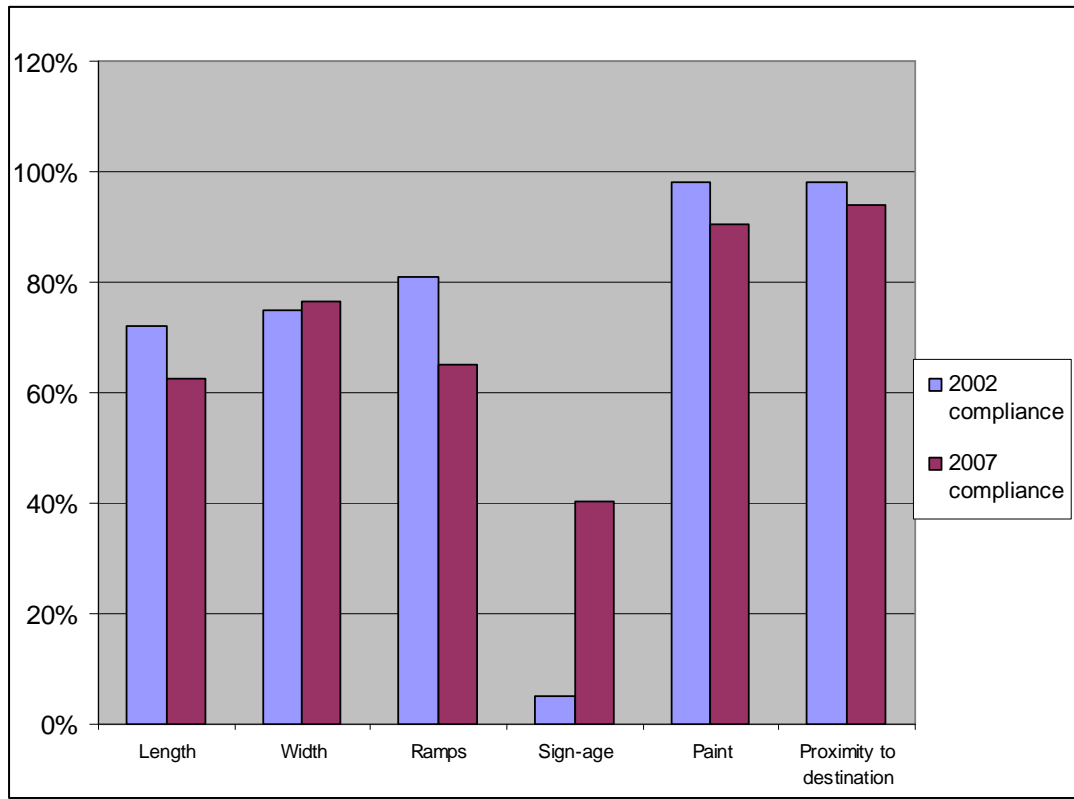
Figure 3-1: Compliance with easy access standards

The same data is shown in Figure 3–1 which also compares the compliance in the 2007 surveys to compliance observed in the 2002 surveys.

Group centre name	Number of Disabled spaces	Length	Width	Ramps	Sign-age	Paint	Proximity to destination
Ainslie	4	4	3	4	0	4	3
Calwell	5	3	5	5	0	5	5
Charnwood	6	1	4	6	3	3	6
Chisholm	4	4	4	4	4	4	4
Coleman Court	21	14	18	8	2	21	21
Curtin	6	4	1	6	0	6	6
Dickson	31	16	23	16	0	31	31
Erindale	18	11	16	16	11	13	18
Hawker	8	7	8	6	8	8	8
Jamison	14	3	4	5	8	8	5
Kaleen	6	0	6	3	2	6	6
Kambah	1	0	1	1	0	1	1
Kingston	11	7	9	8	9	11	11
Kippax	18	18	17	8	10	16	18
Lanyon	8	4	5	5	0	8	8
Manuka	14	12	14	12	10	14	14
Southlands	16	8	7	10	5	14	14
The Village	7	7	6	5	6	6	7
Wanniassa	3	3	3	3	3	3	3
Total	201	126	154	131	81	182	189
